## Caballo Dam Intake

Operational Issue

2016

## Intake Structure flow restriction

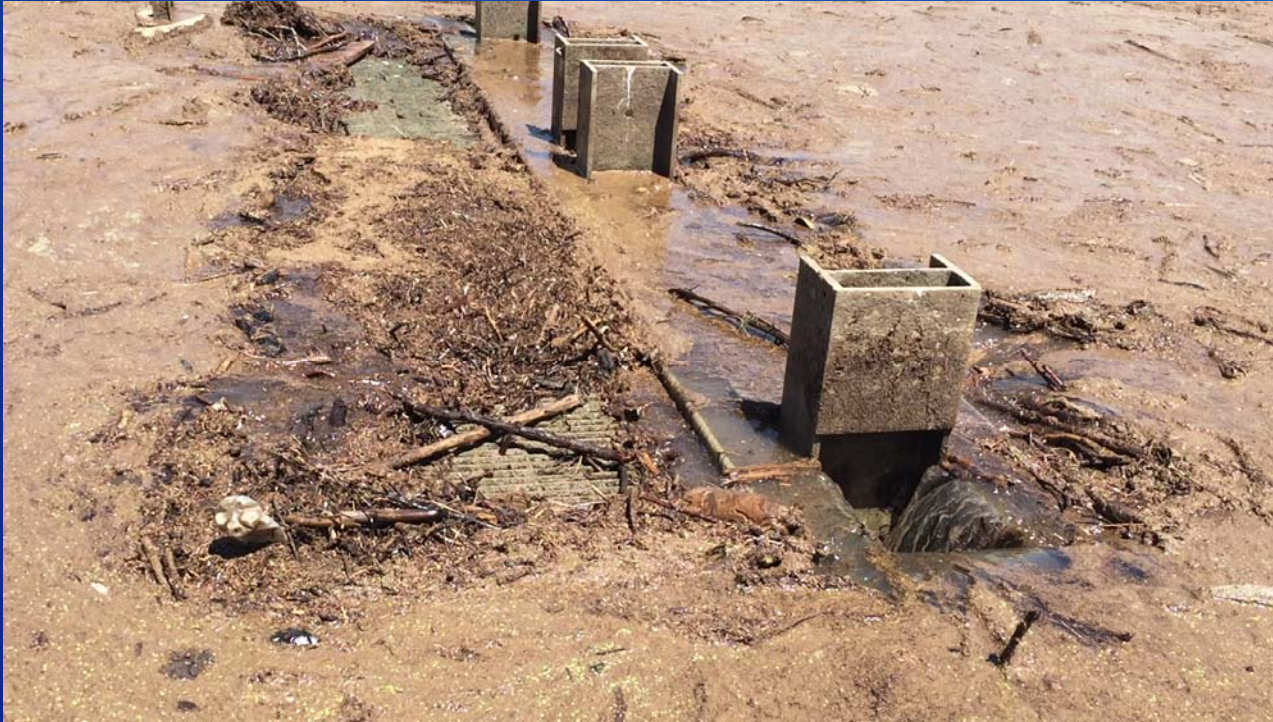
- During normal operation flows started to decrease without any changes to gate settings. (Saturday, August 13, 2016)

- Flows were approximately 100 cfs below expected release and was steadily decreasing.
- What was causing this?
  - Debris around intake
  - Sediment
  - Gate Failure
  - Debris in tunnel

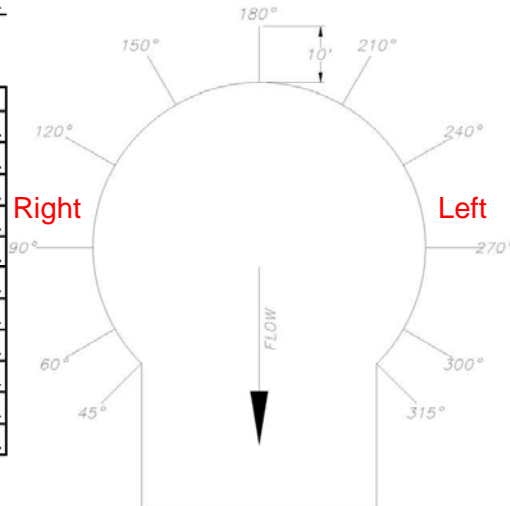
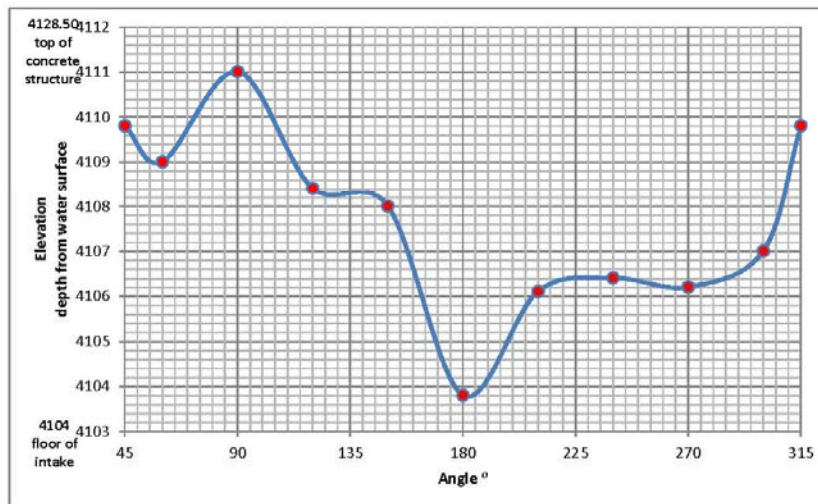
### Caballo Dam Probing Intake Structure

- @ 90 – 7 ft of silt build up
- @ 180 – 0 ft of silt build up
- @ 270 – 2 ft of silt build up

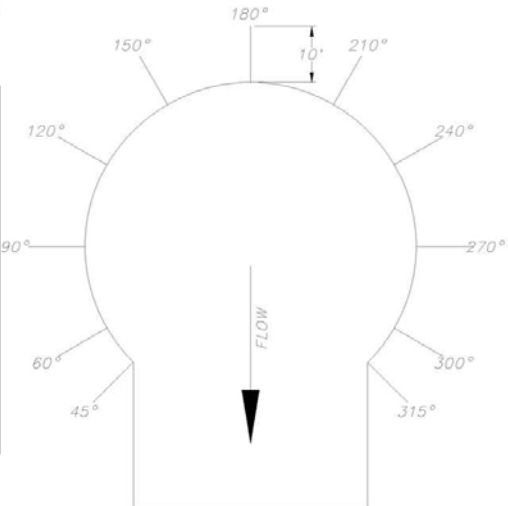
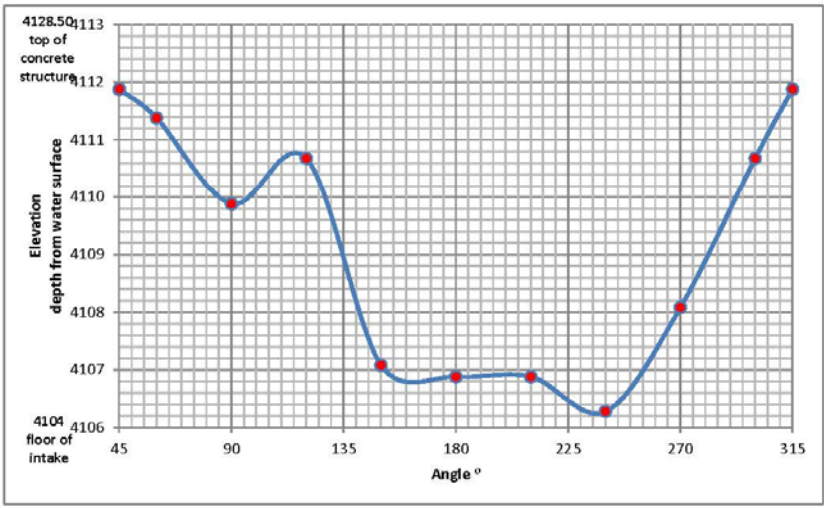
Caballo Dam  
 Probing Intake Structure  
 Date: 9/14/2011  
 Lake Elevation: 4128.88  
 Readings Taken By: B. Kalminson

- @ 90 – 6 ft of silt build up
  - Decrease of 1 ft
- @ 180 – 3 ft of silt build up
  - Increase of 3 ft
- @ 270 – 4 ft of silt build up
  - Increase of 2 ft

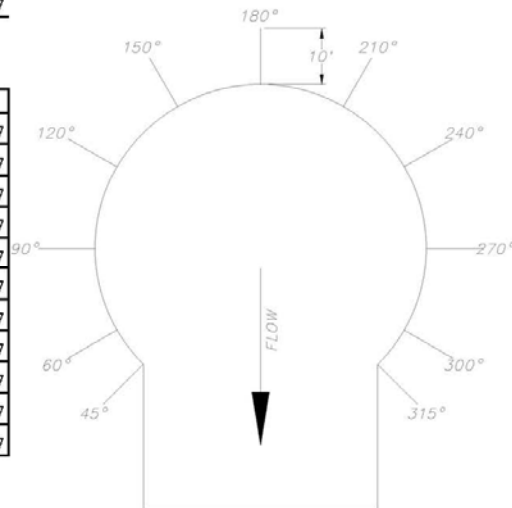
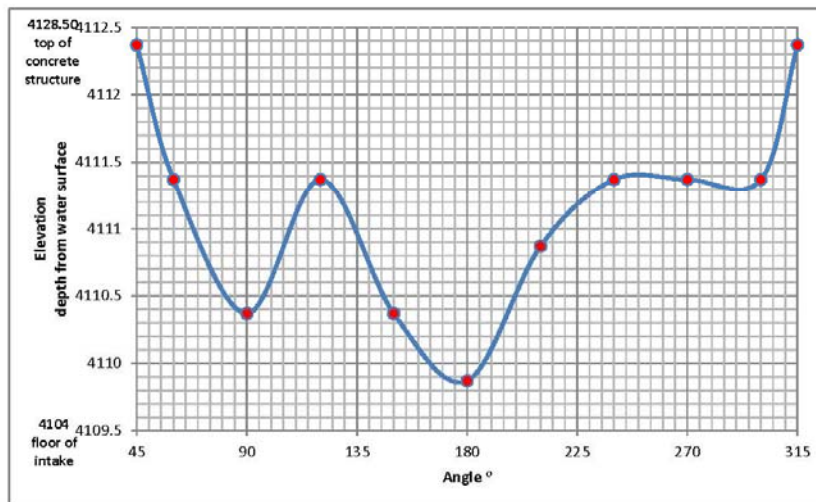
## Caballo Dam Probing Intake Structure

- @ 90 – 6 ft of silt build up
  - No change
- @ 180 – 6 ft of silt build up
  - Increase of 3 ft
- @ 270 – 7.5 ft of silt build up
  - Increase of 3.5 ft
- Steady increase from 2005 to 2014 with a build up of an average of 3 foot every three years.
- With this average increase it can only be assumed that in 2016 the intake had an average of 9 foot of silt build up.

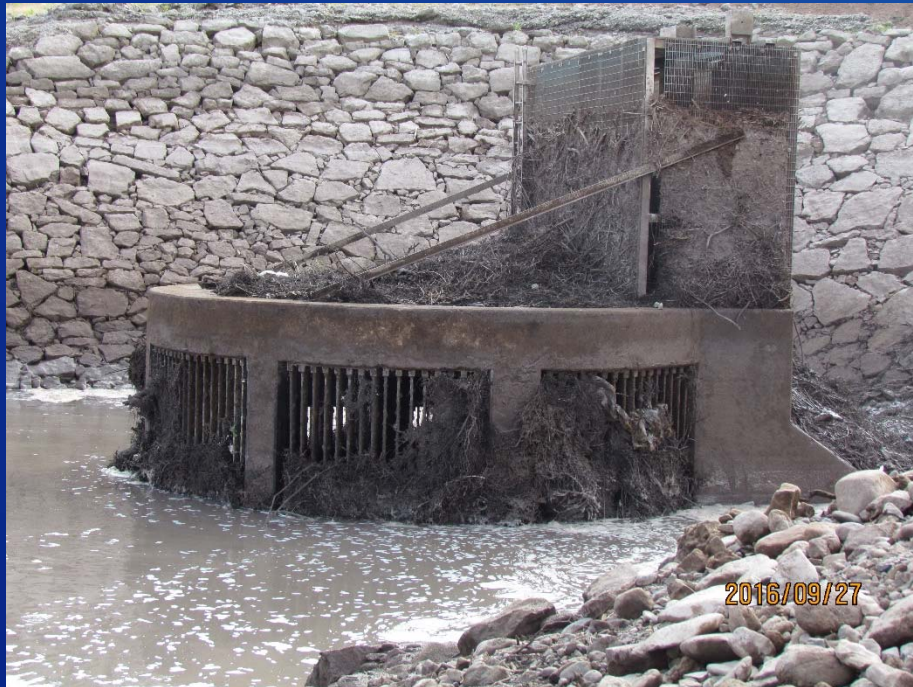
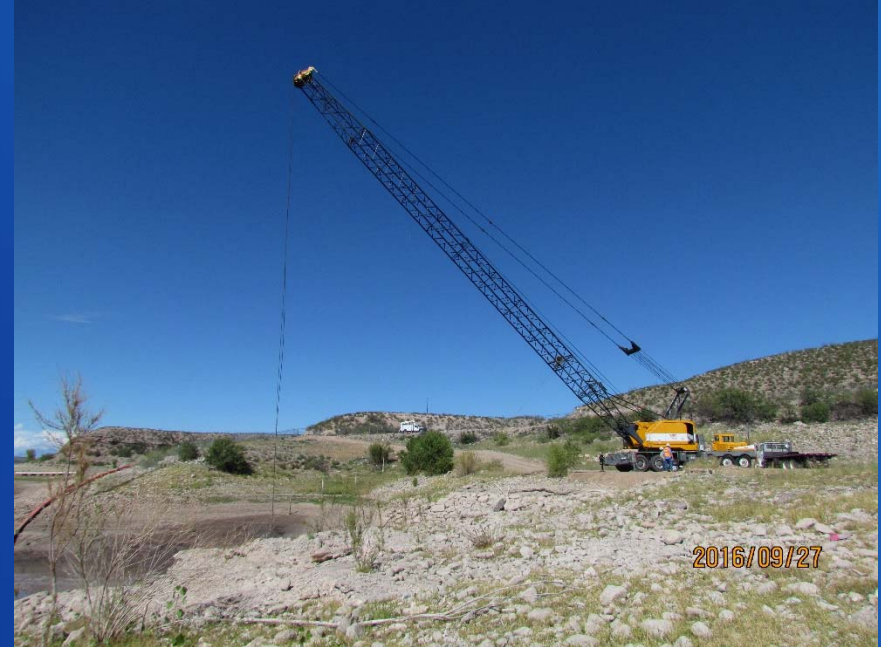
# Crane Work Day 1

- Intake has lots of debris on the trash rack portion of the structure. First Day on site.
- Crane arrived on site September 27
- Started work that afternoon

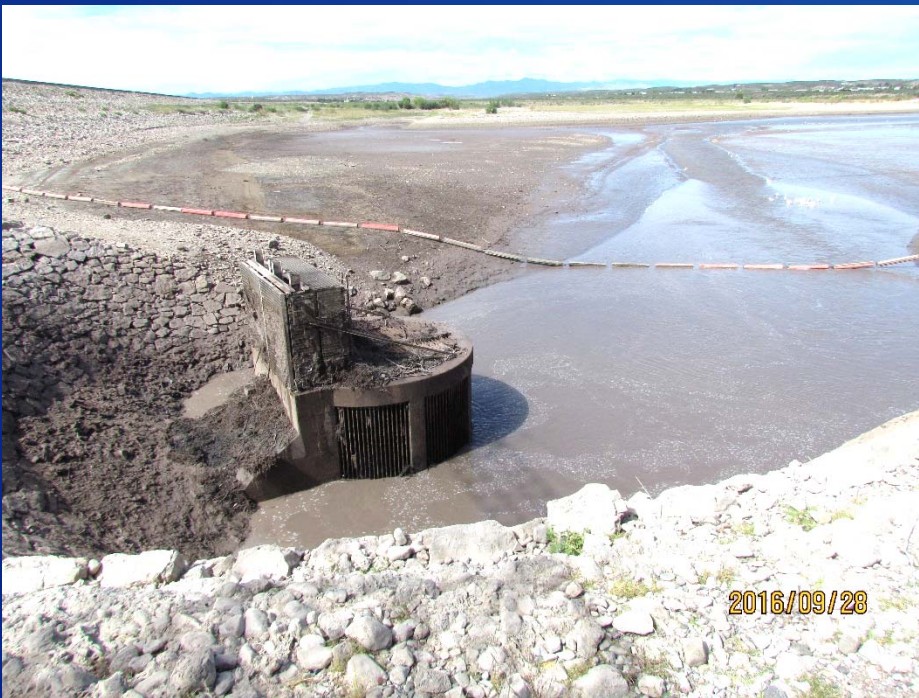
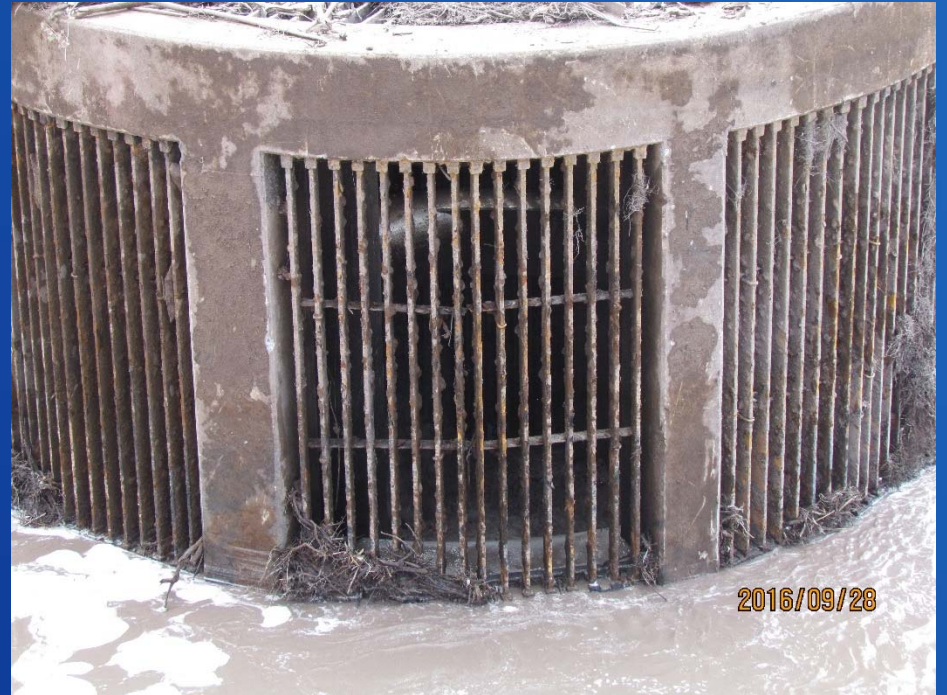
# Crane Work Day 2

- Progress had been made the first day along with reservoir continuing to drop
- Debris has been knocked off with bucket

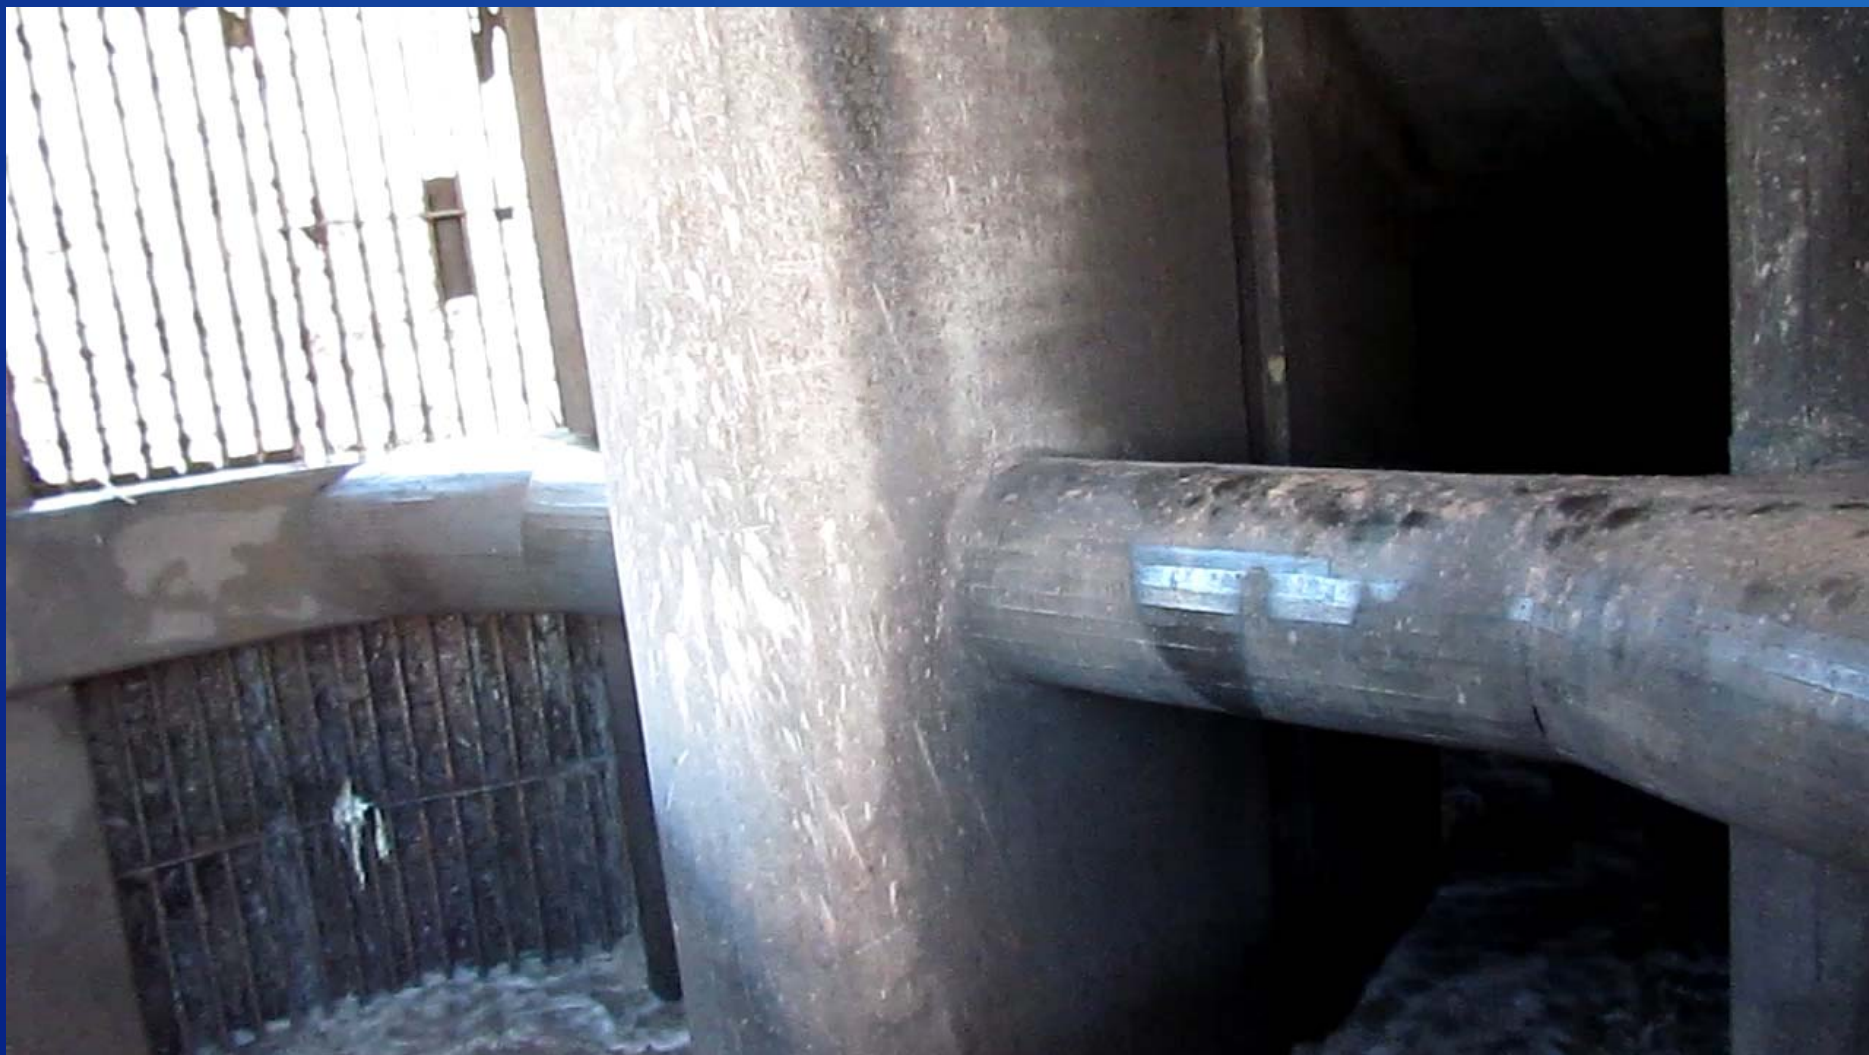
Interior of intake structure looking in from RIGHT side.

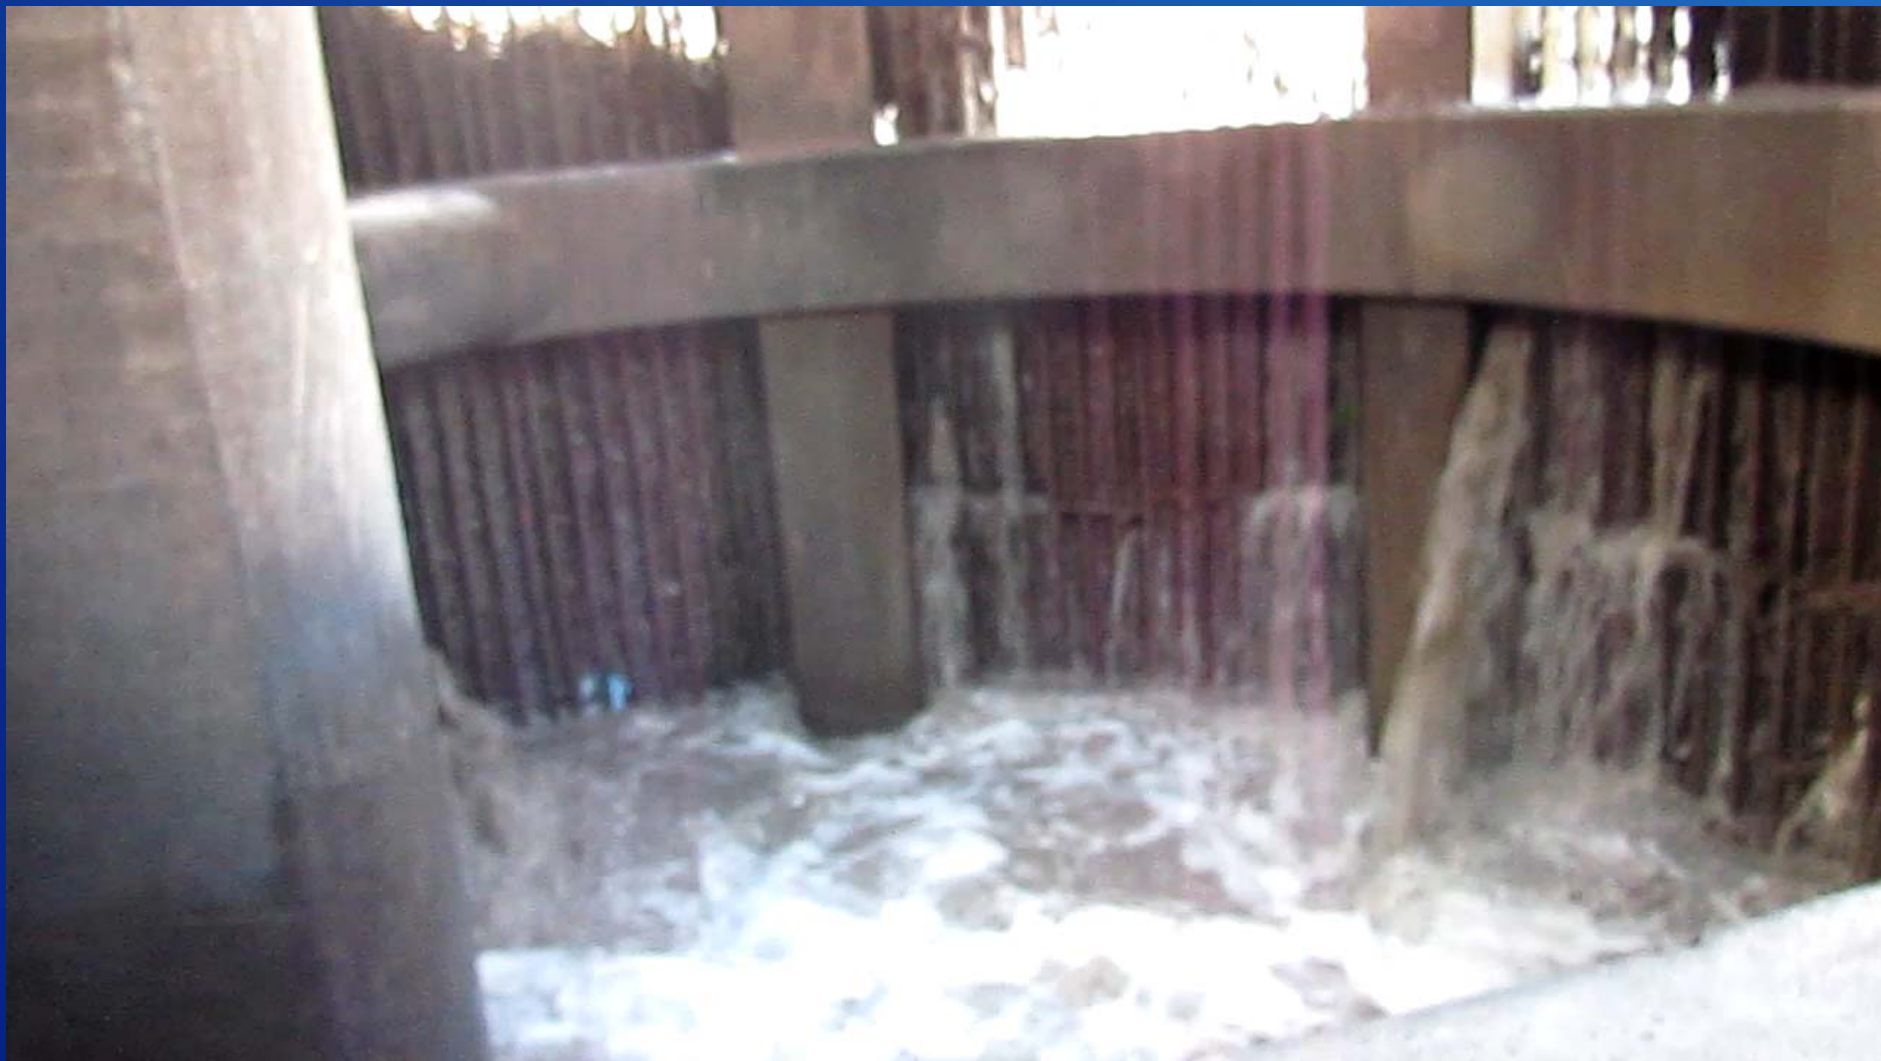
Interior of intake structure looking in from LEFT side.

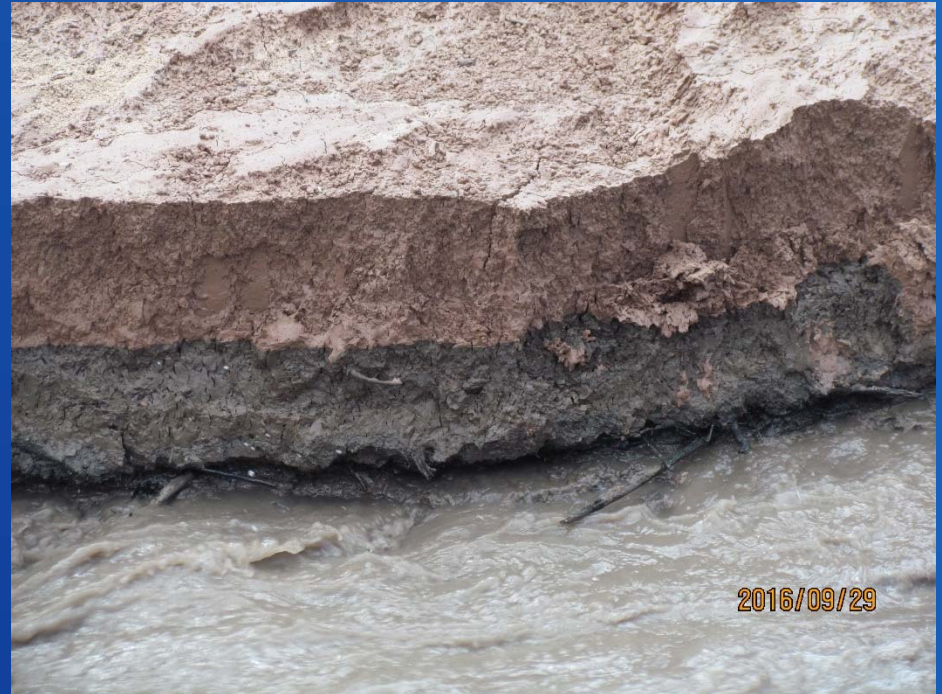
- See different layers of history in silt

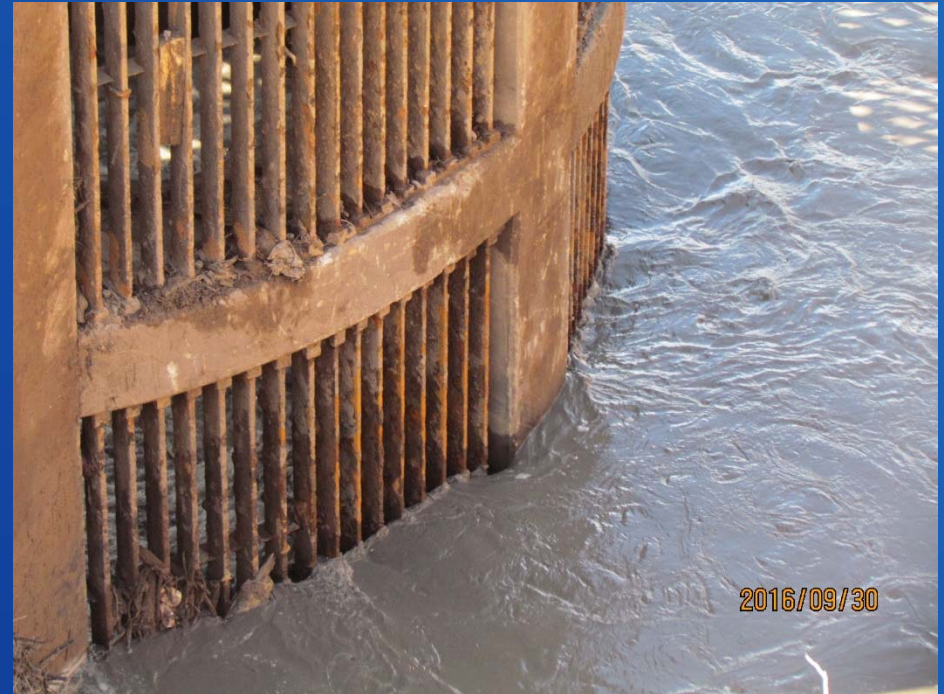
- Up-close look at intake trash rack

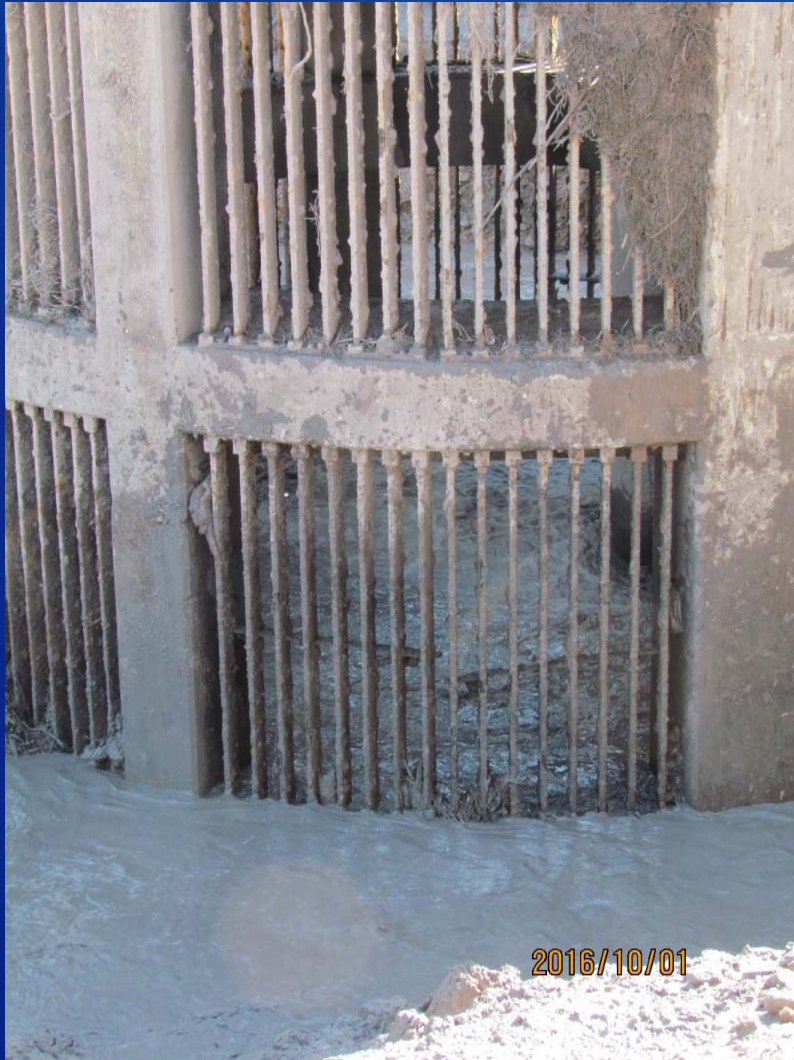
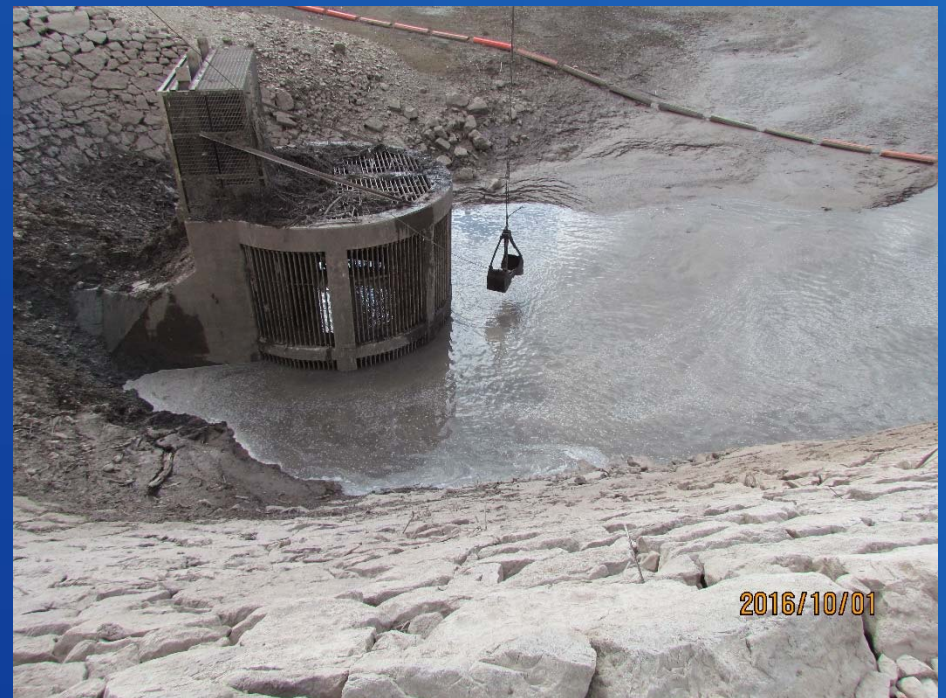
# Crane Work Day 5

- Intake cleaned as much as possible
- Gates closed but still working to get silt that flowed in out
